CATANIA ENGINEERING ASSOCIATES, INC.

Consulting Engineers & Land Surveyors

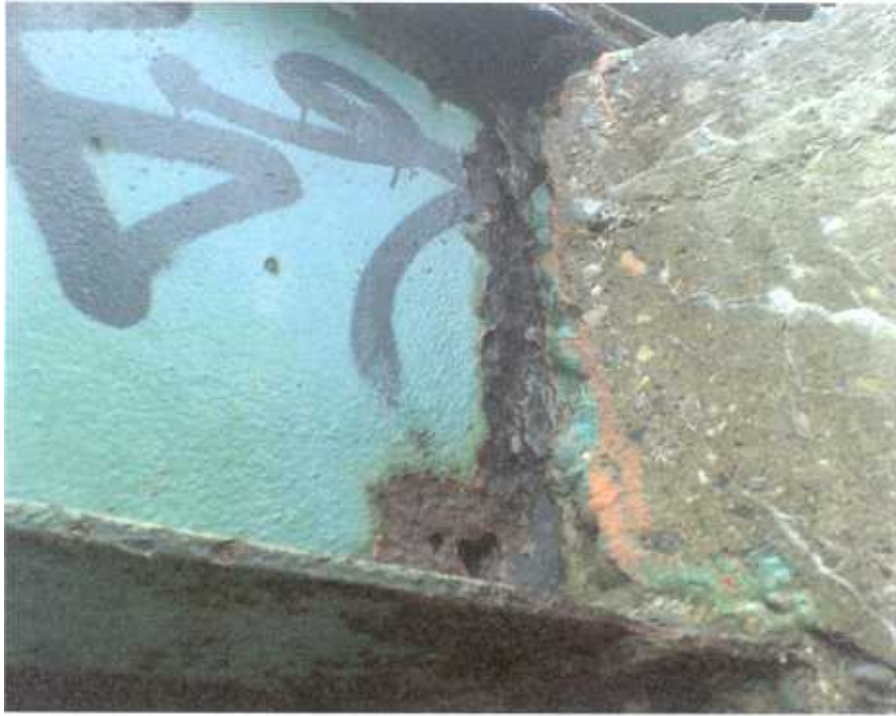
Photo 3 – Deterioration of steel beam encased in concrete at abutment.

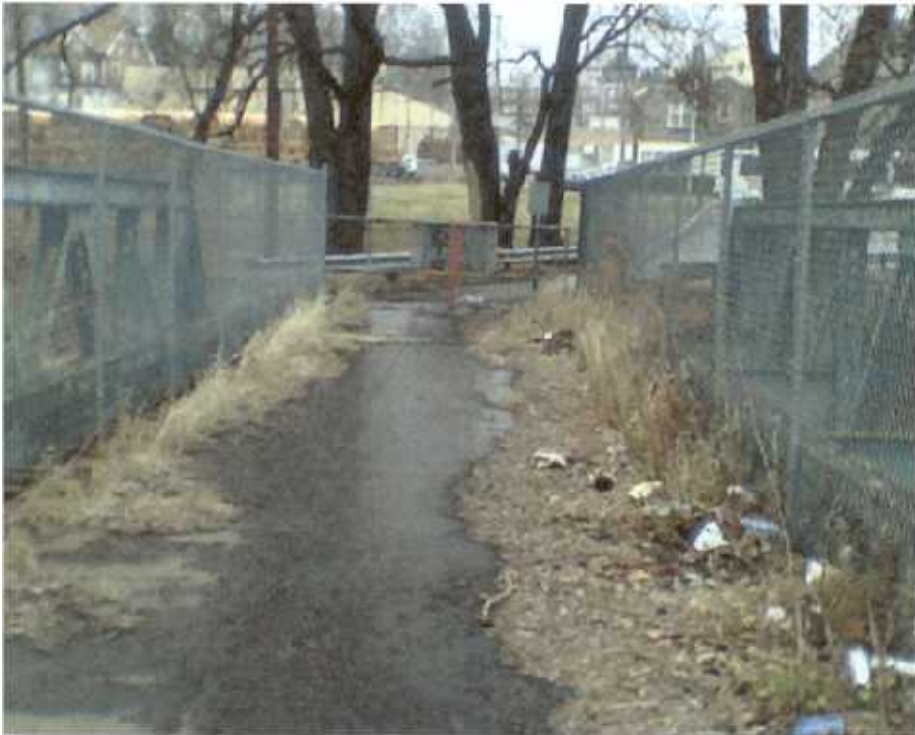
Photo 4 – Looking south at steel deck. Note debris that collects due to flooding and leaves.

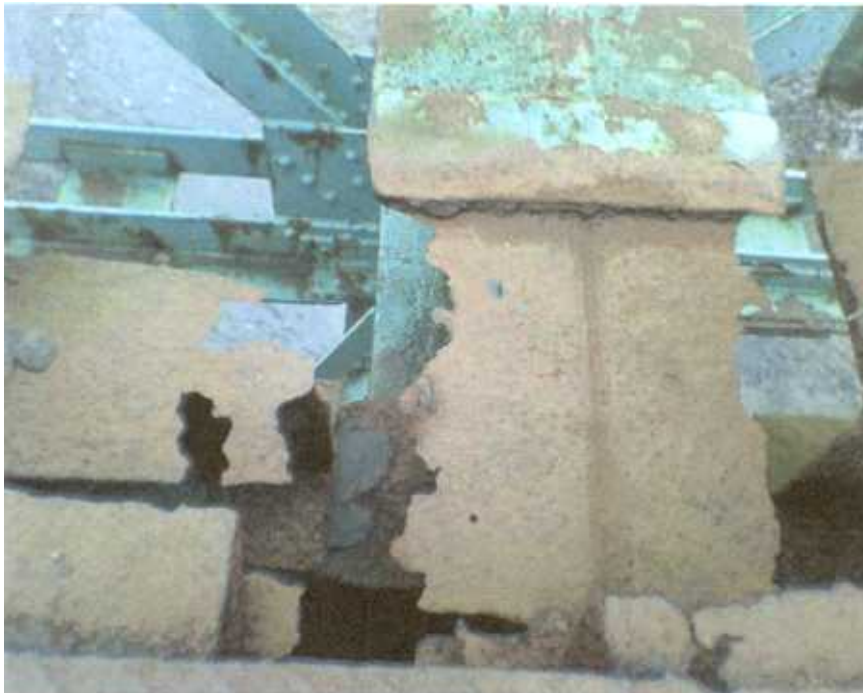
Photo 6 – Looking at top of floor beam at north end of bridge. Note deterioration of top flange.
