*Historic Assessment for  
1000 Main Street  
Darby, PA*

Submitted To:  
Delaware County Planning Department

Submitted by:  
*Kise Straw & Kolodner*

15 January, 2002

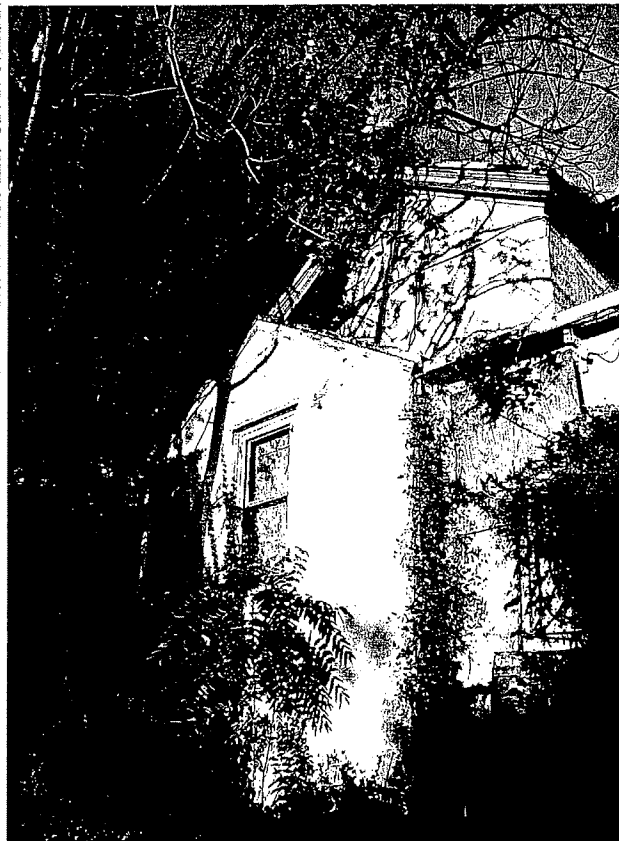
*Section 1 with Addition 1*

Construction of Addition 1 is concealed, but may reasonably be assumed to be similar to Section 1, frame walls on a stone foundation. It appears in reasonably good condition. Unlike Section 2 and the other 6 additions, it may be appropriate to leave it in place and stabilize it as recommended for Section 1. It may also be appropriate to remove this portion since it would yield a relatively small space for the effort.

Addition 1 is a sympathetic one story extension to the rear of the kitchen ell of the original house. While the exterior shape and visible detail suggests that it was added early in the history of the house; however, little remains of original surfaces and detail within. Plaster walls and ceiling are in poor condition. Original flooring is covered in layers of sheet goods. The window, door, and trim are in poor condition.

- Remove stucco, replace portions of siding and trim, provide new battens on siding, repaint.
- Close window with temporary closure (plywood panel bolted through to strongbacks and painted to resemble the sash).
- Close door opening with temporary closure.
- Regrade after removal of concrete porch and adjacent addition.
- Repair, replace roof.

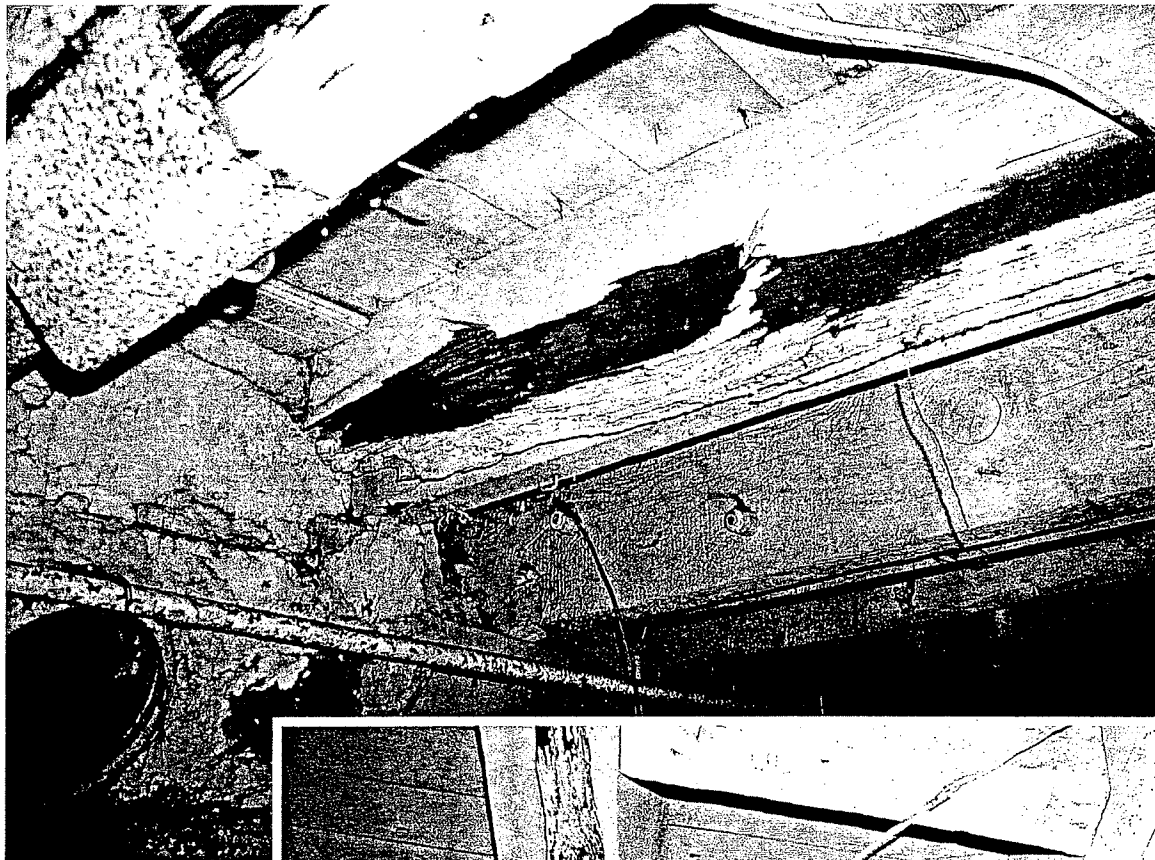
*Damaged Framing*

Section 1 is in better structural condition than any of the other portions of the house. There is extensive deterioration throughout the first floor joists and beams due to insect damage (powder post beetles). Exterior wall sills, particularly on the northwest elevation are badly deteriorated, resulting from moisture penetration through the exterior walls. Much of the whitewashed facing on the interior basement walls has disintegrated, exposing the stone and soft mortar. Additional steel and wood beams and wood posts have been installed to support the building in the vicinity of the main stair. The original basement stair was removed and a new stair opening cut under the main stair. This work did not compensate for the loss of structure resulting from cutting through most of the joists. As a result the building sags very badly in the vicinity of the hall connecting the dining room to the original kitchen. The exterior stucco has disintegrated in many areas along the first floor sill, particularly on the northwest side of the building. The appearance of bulging in this area is, however, more a result of the way the stucco was applied over the protruding trim, rather than a sign of deterioration and subsidence of the wood building. The built in gutters of the tin roof have failed along the left front of the house. The resultant rotting has destroyed a portion of the framing, sheathing and cornice, and exposed the attic to the weather.

- Replace portions of sills and corner posts, approximately 30%.
- Replace or sister floor joists, approximately 60%.
- Reframe under main stair to add header and trimmers, and add column and footing.

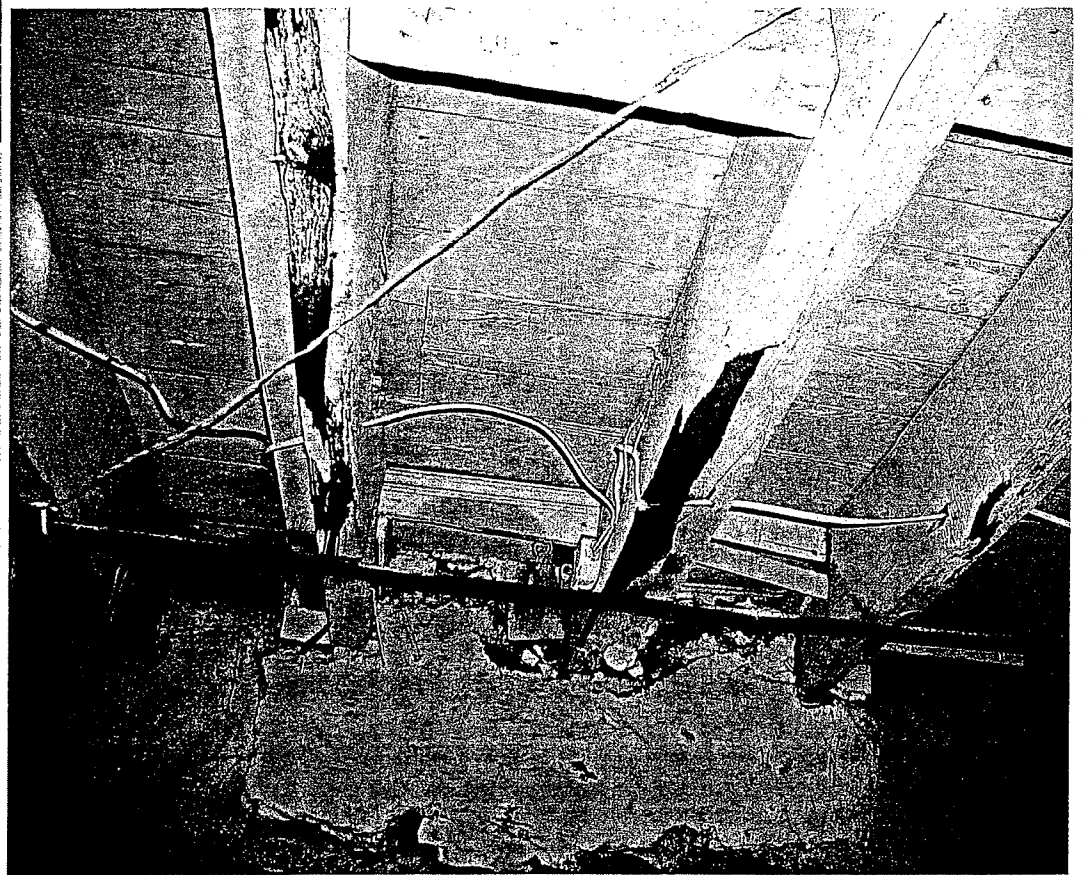
*Damaged Framing*

The structure is in poor condition, except for the foundation walls and perhaps the concealed roof structure. The floor joists, subfloor and finished floor have been repeatedly wet by a failed portion of roof and are buckled and rotten. Original exterior walls of this addition are mostly concealed by later additions. No visible significant features remain to date the structure; refer to the assessment of Addition 2 for related observations.

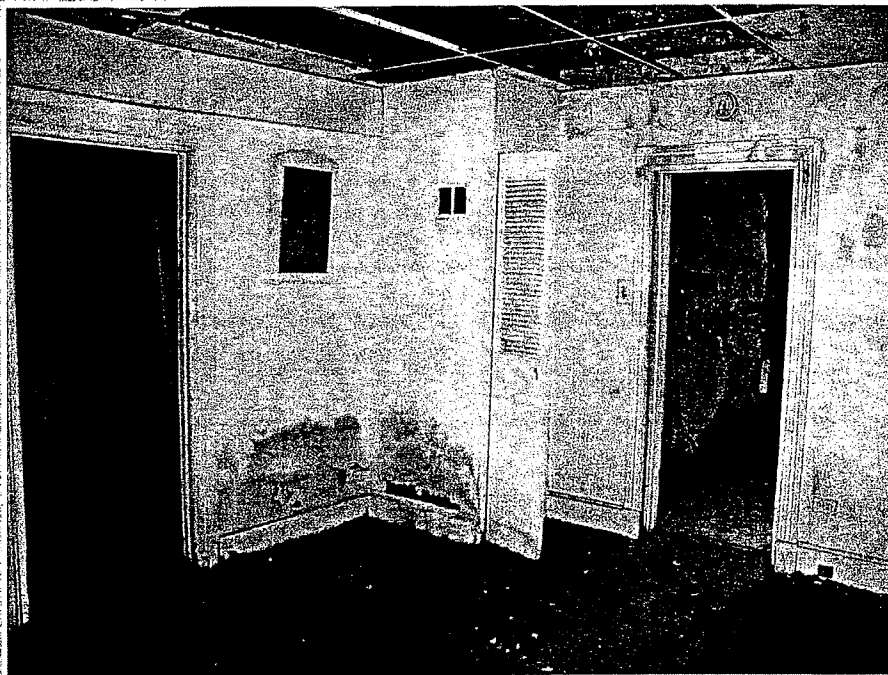
Section 2

The first floor of the addition consists of a major room to the rear of the Section 1 living room, and a hall and a bathroom. None of these spaces is distinguished in any way. None are in good condition. The roof contains significant leaks, the ceiling has fallen and the floor is ruined and rotting. Walls are plaster and are in fair condition. The ceiling height was 8'-5".

required to eliminate the problems of this Section is demolition of the wood structure, demolition of the foundation if replacement is not contemplated, and regrading.

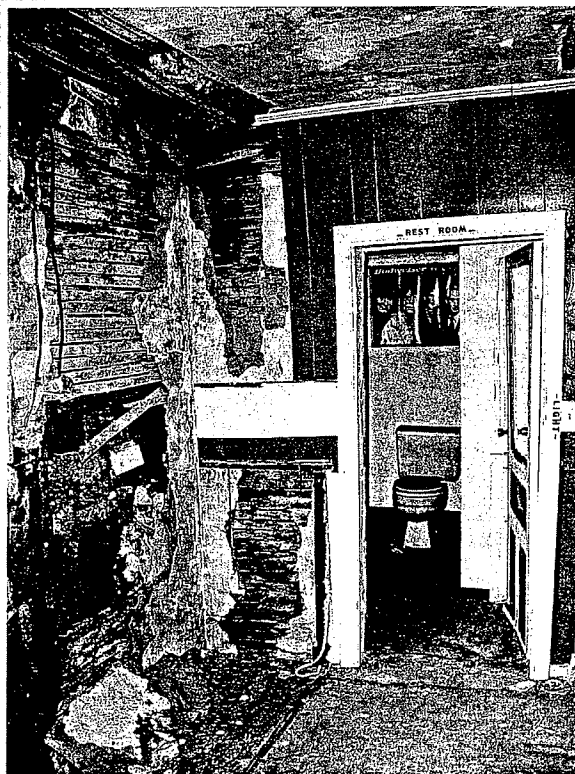
Addition 5 is a one story frame extension to the rear of Section 2. It may have been a 20'-9" wide by 8'-0" deep open porch as the foundation appears to be piers with wood board and stucco infill. It contained a kitchen and a bathroom. This addition is in ruinous condition due to plumbing and roof leaks.

Addition 5 is a one story frame extension to the rear of Section 2. This addition is in ruinous condition, most surfaces are in poor condition or are missing. The ceiling height was 8'-0".

Demolition of Addition 5 is recommended.

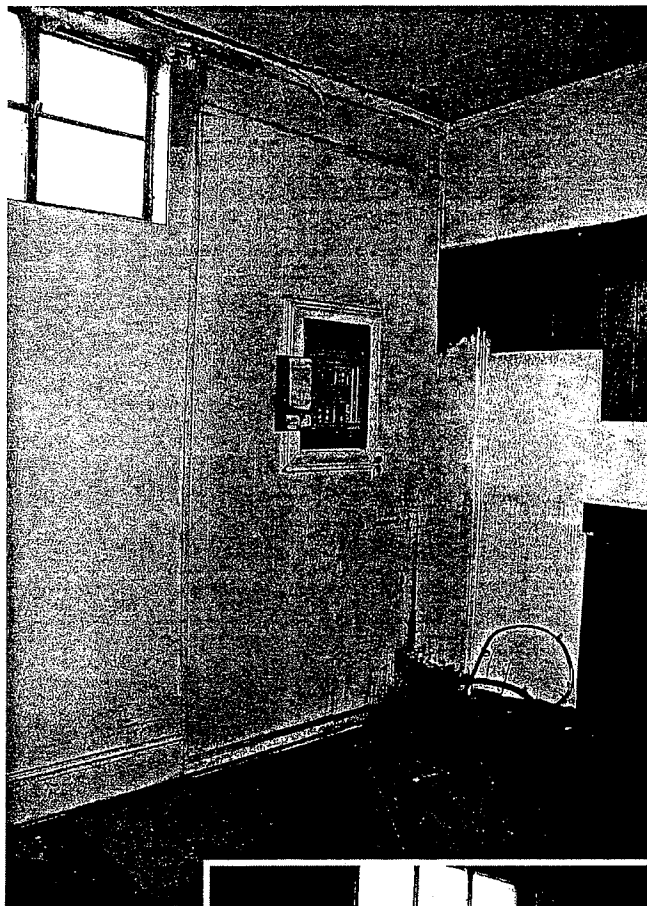
*Addition 2*

Work to stabilize Addition 2 is problematical since the structure cannot remain if Section 2 is removed as recommended.
